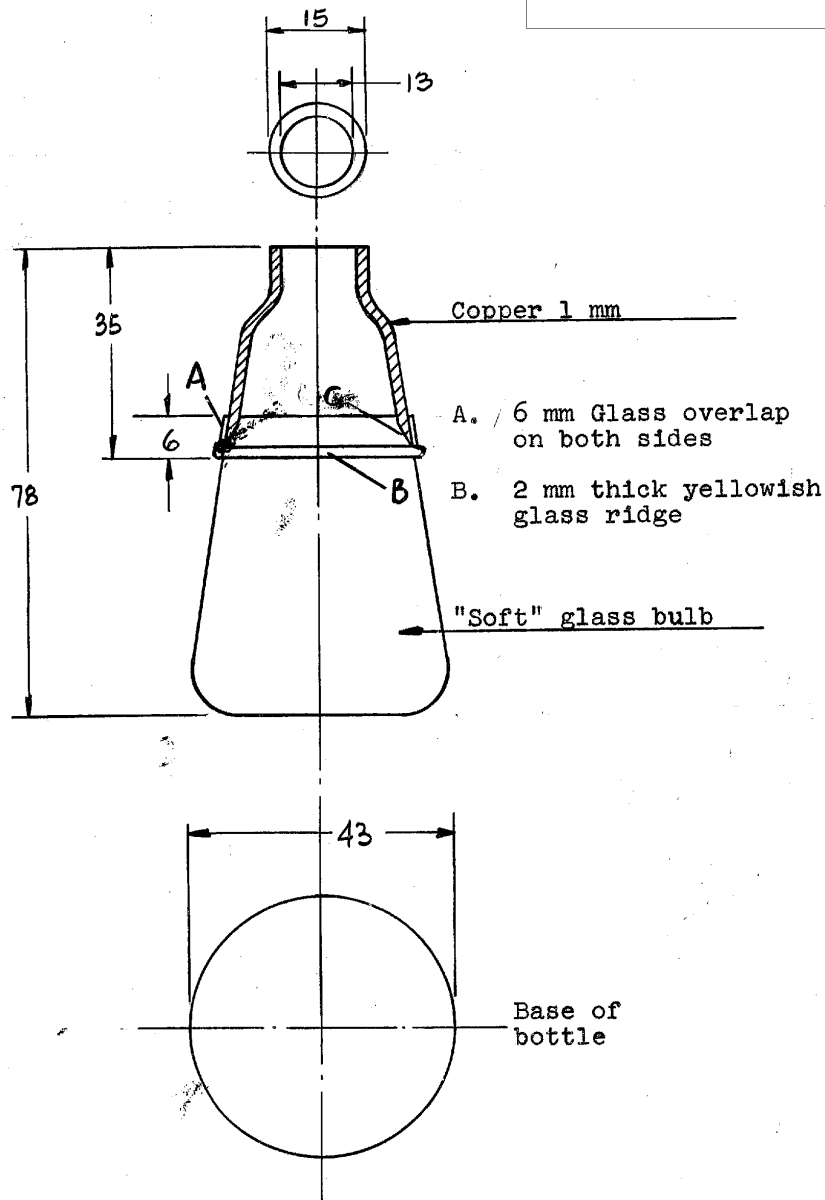
- A. A 6 mm glass overlap (inside and out) showed a bright reddish surface through glass which appeared to be 0.5 mm on both sides
- B. A 2 mm high glass ridge appeared yellowish
- C. Copper ferrul was fined off on both sides to an edge. All welding had been done by a Russian woman glass H.F. welding operator in $2\frac{1}{2}$ to 3 minutes
